12" Tee Strengthening

Petronas Penapisan Melaka – Dec 2017

iowrapTM

formerly known as ProWrapTM

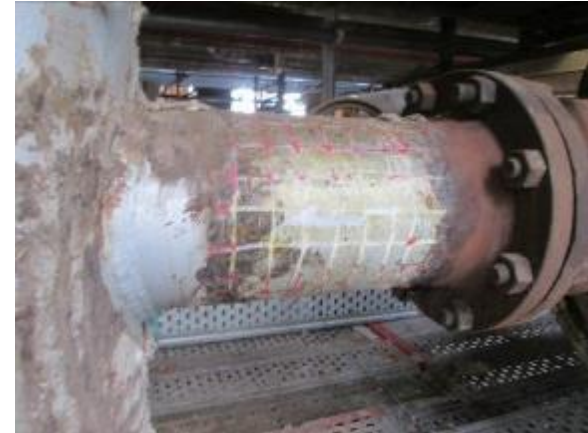
Before

Medium	HC
Diameter	12" tee and 6" straight pipe
Temperature	145°C
Pressure	15.1 bar
Types of defect	Thinning

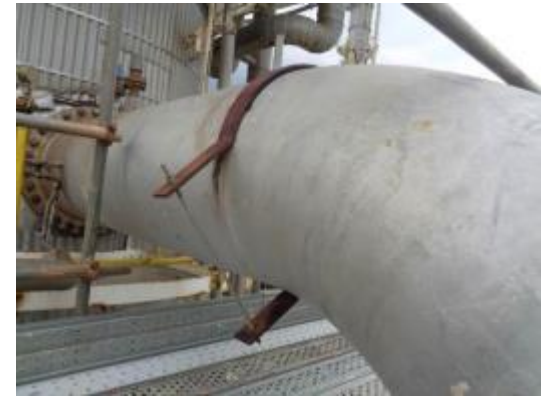
Before

Medium	HC, Benzene and Toluene
Diameter	30 inch
Temperature	163°C
Pressure	1.2 bar
Types of defect	Leak (wrap over clamp)
Repair Length	1 meter

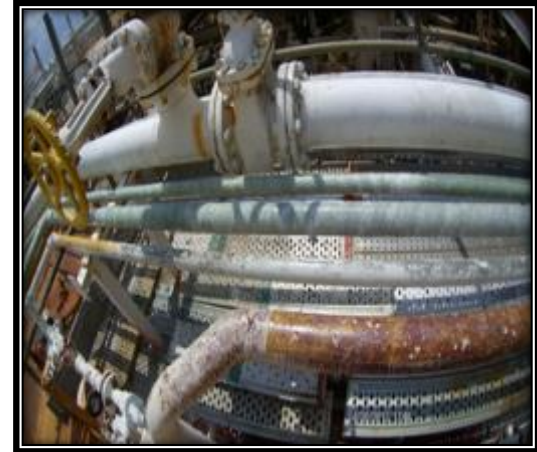
Before

Medium	LPG
Diameter	2 inch & 1 inch
Temperature	90°C
Pressure	8 bar
Types of defect	Severe corrosion & external metal loss
Repair Length	80 meter

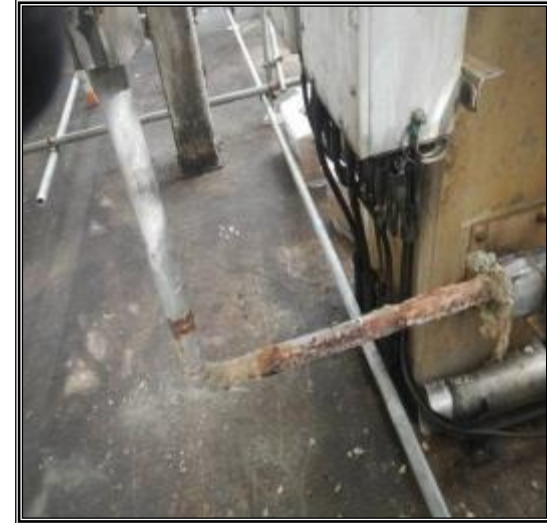
Before

Medium	HP Condensate
Diameter	1.5 inch
Temperature	188°C
Pressure	10 bar
Types of defect	Severe corrosion & external metal loss
Repair Length	0.5 meter x 5 spools

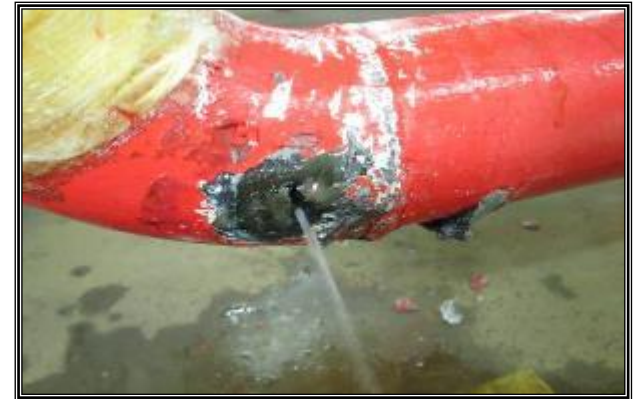
Before

Medium	Fire Water
Diameter	3 inch (Elbow)
Temperature	Ambient
Pressure	5 bar
Types of defect	Leak repair

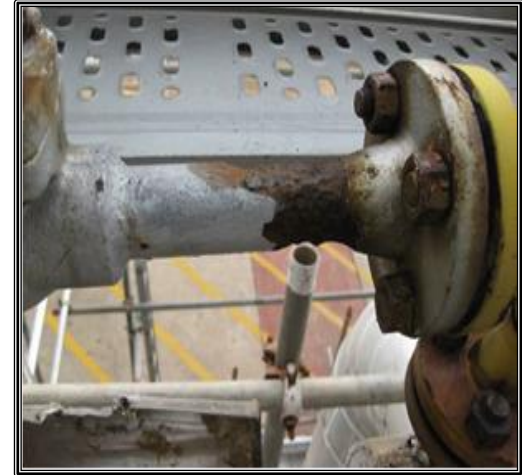
Before

Medium	Liquefied Petroleum Gas
Description	Straight pipe
Diameter	¾ & 1 inch
Temperature	160 °C
Pressure	0.2 bar
Types of defect	Internal metal loss and wall thinning
Repair Length	0.9 meter

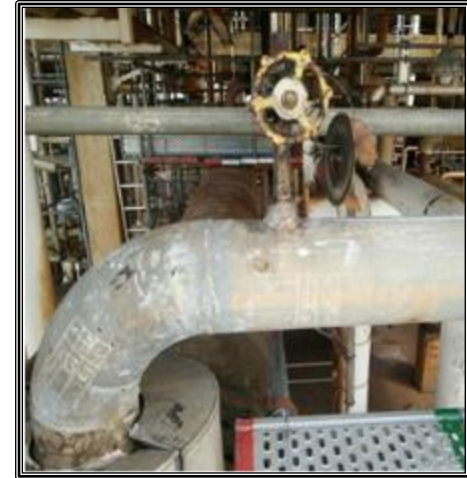
Before

Medium	Crude/condensate
Description	Straight pipe
Diameter	¾ & 1 inch
Temperature	160 °C
Pressure	6.5 bar
Types of defect	Internal metal loss and wall thinning
Repair Length	0.9 meter

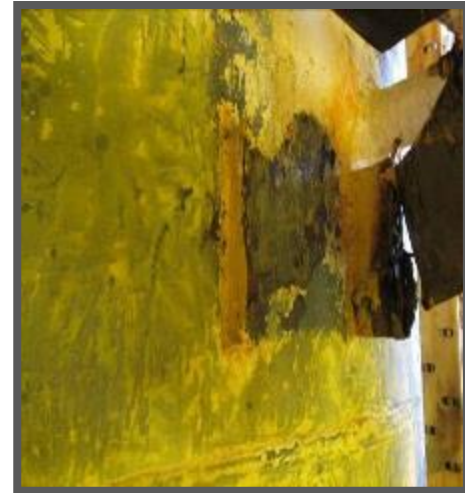
Before

Medium	Flare
Description	Knock Out Drum
Temperature	33°C
Diameter	96 inch
Pressure	0.7 bar
Types of defect	Wall Thinning
Repair Length	1 m2

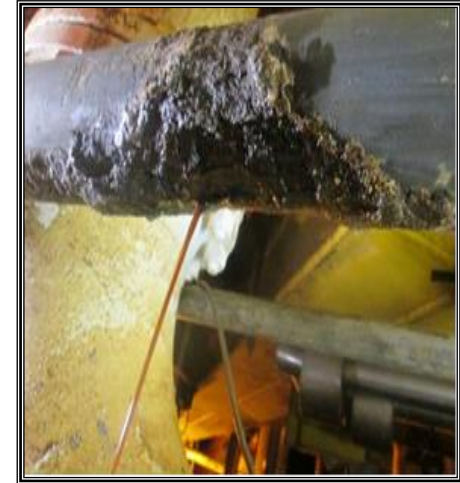
Before

Medium	Hydrocarbon
Description	Straight pipe
Diameter	3 inch
Temperature	200°C
Pressure	3.5 bar
Types of defect	External metal loss and wall thinning
Repair Length	0.8 meter

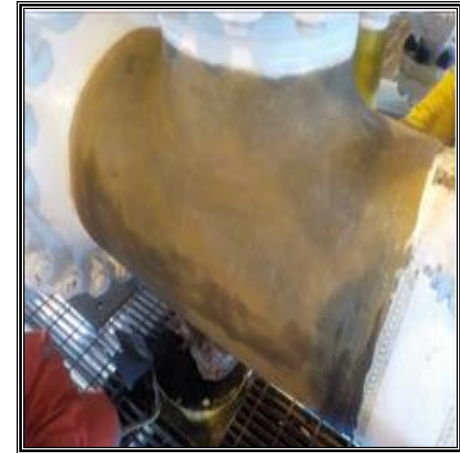
Before

Medium	Hydrocarbon
Description	Tee
Diameter	18 inch
Temperature	65°C
Pressure	107 bar
Types of defect	External metal loss and wall thinning
Repair Length	0.7 meter
